**Auto Fire &  
Safety Consultants**

Relative to the Matter of  
*Roxana Regaldo Harrison and Joseph Santellana Individually and  
as Representative of the Estate of Jonathen Santellana vs. CH  
Condominiums GP, LLC and Rey Garza*

**AFSC File: 15120**

November 6, 2015

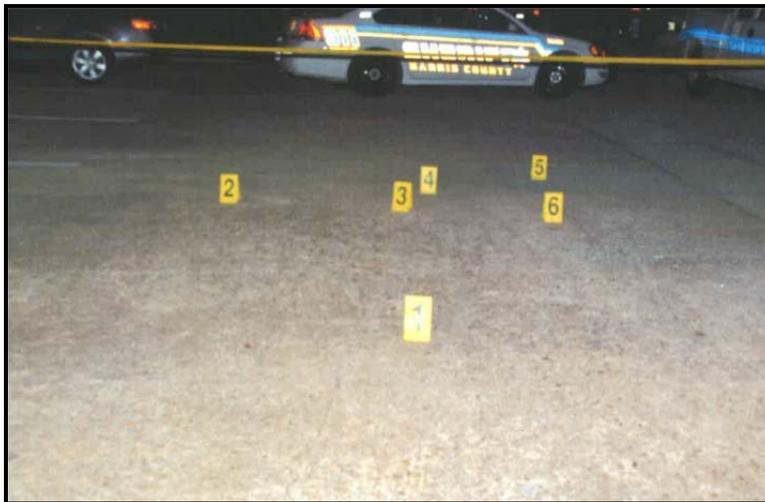
Six of the seven bullet casings identified, were found grouped in a relatively small area with regards to bullet casing ejection. Casing trajectory from semi-automatic pistols is typically to the right and slightly rearward of the firearm/shooter. This indicates that these six rounds were fired from a single approximate area and a single approximate direction, with only one casing in the area of the parking space.

11. The factual evidence of the location of the 40 caliber cases, in the middle of the parking lot, make it impossible to believe Mr. Garza's testimony of firing all the rounds (4-5 rounds per Garza's testimony) while trapped between Mr. Garza's Dodge and the door of Mr. Santellana's Chevrolet Malibu, as the Malibu was exiting (1 to 2 seconds). Mr. Garza's testimony regarding where he fired the Glock and how many times he fired the Glock is not correct. This is a false statement according to the positions of shell casings shown in Photograph 2 and 4.

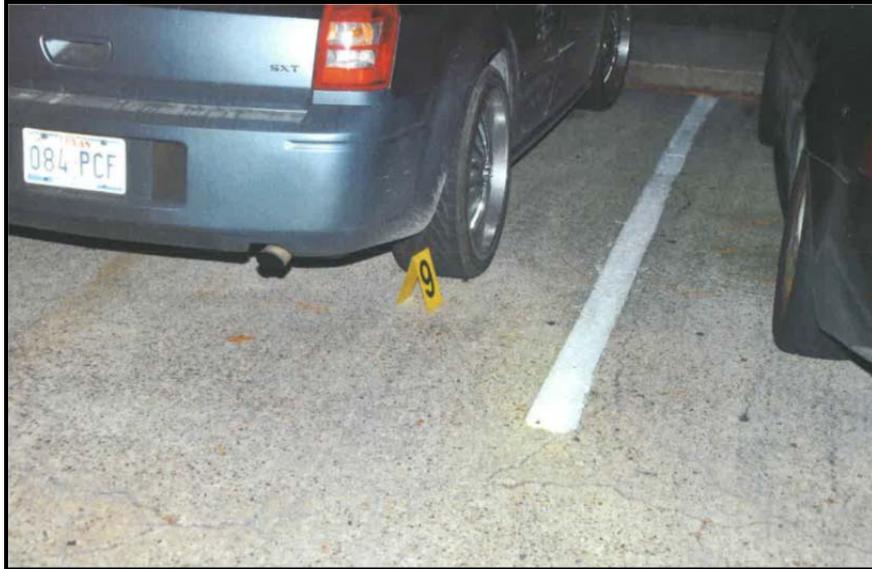
Photograph 3

A seventh casing was identified and located slightly rearward of the rear passenger wheel of a Dodge Magnum. The Chevrolet Malibu was parked to the right of this vehicle in the parking spot now occupied by another vehicle. This is the round that was most likely fired from the front of the vehicle, penetrating the upper driver's side "A" pillar. As Unit 1/Malibu was backing out, the officer removed the firearm from the holster, throwing it onto the windshield and firing from the driver's side front, not from the area between the door and the occupant.

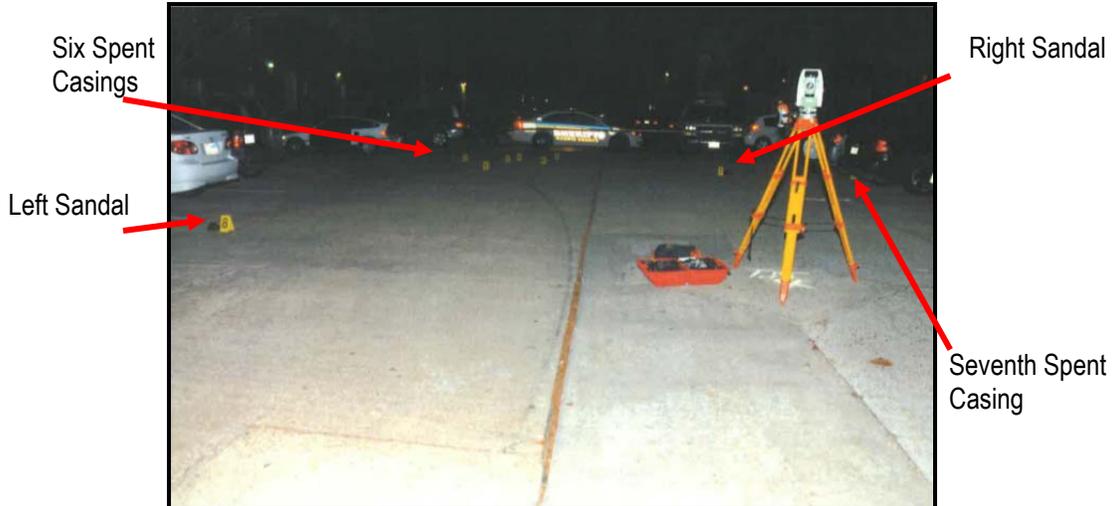
Photograph 4

In total, seven bullet casings were identified and labeled as evidence. Six casings were grouped together and one was identified in a different location. The pair of sandals identified and found separated from each other. The six casings shown above could not have been fired from the car spaces on the right side of the photograph. These shots were fired from the middle of the parking lot at a vehicle that was exiting the parking lot.

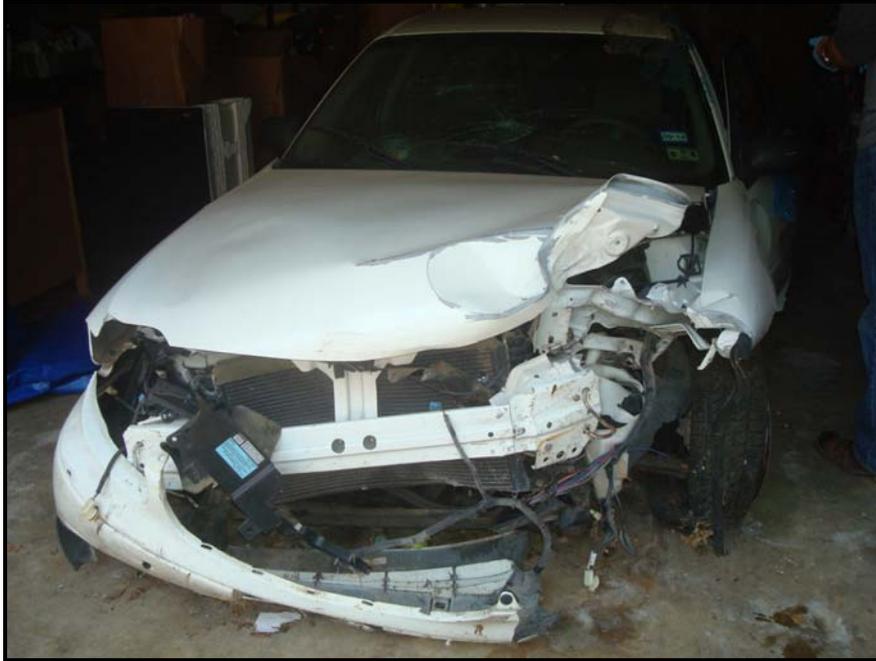
Photograph 5

The front end of Unit1/Malibu showed evidence of crush intrusion because of a frontal impact, as Jonathen was fleeing from the shooter in the parking lot of the apartment complex. The front driver's side of Unit 1 showed significantly more damage than the passenger side. The driver's side front wheel was pushed rearward during the impact and the driver's side front quarter panel was pushed rearward and upward. The front bumper was pushed upwards and rearwards and the driver's side front fender well experienced lateral intrusion resulting in damage directed towards the centerline of the vehicle. The front headlight assemblies are no longer present and the front bumper body panel has been broken and is no longer properly mounted to the vehicle. The driver's door was damaged because of the impact with the red truck, rotation and impact with the curb.

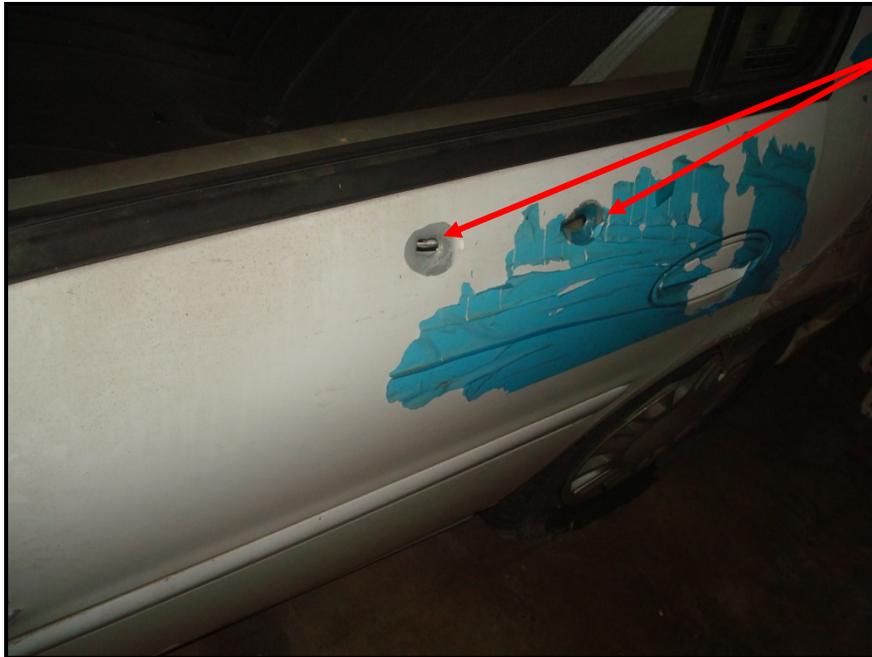
Photograph 6

Two bullet entry holes from bullets fired rearward of the vehicle. Driving away from the shooter.

The right rear driver's side door panel had evidence of multiple bullet impacts. Dowels were used to assist in trajectory identifications. The elongated entry holes are evidence of a bullet with a trajectory having an acute vector angle rearward of the vehicle. These elongated entry holes show that the individual firing the bullets was not standing alongside the driver's or passenger's door, but was rearward of the rear driver's side door at the time these bullets were fired. These rounds were fired as the vehicle was driving away from the shooter.

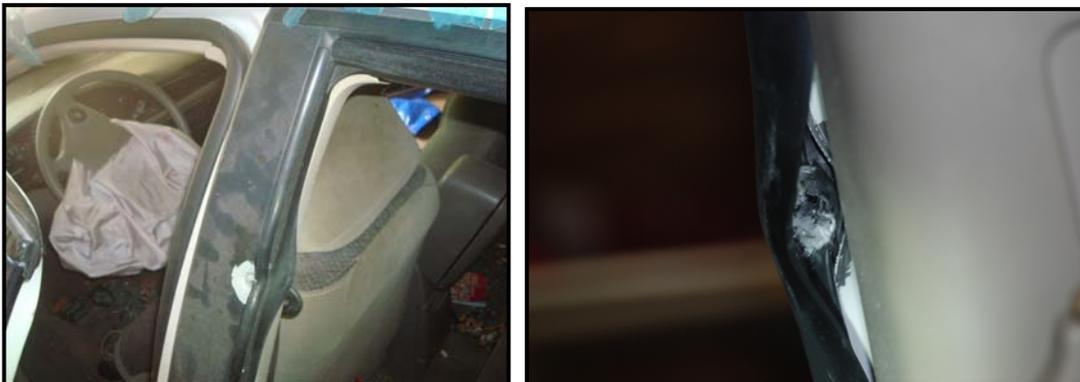
Photograph 7 and Photograph 8

The rear driver's side door has evidence of a bullet impact along the B-Pillar. The bullet impact into the B-Pillar portion of the rear driver's side door resulted in the bullet entering the external fascia of the door and exiting through the backside of the weather stripping leaving a bulge of displaced metals and polymers. This bullet was fired with the firearm roughly perpendicular to the B-Pillar, not from the area between the door and the driver.

There is no evidence any of the 40 caliber bullets were fired from the area between the driver's door and the driver. No bullet entering or exiting damage to the driver's seat shown above, no powder burns. No bullets penetrated the driver's door.

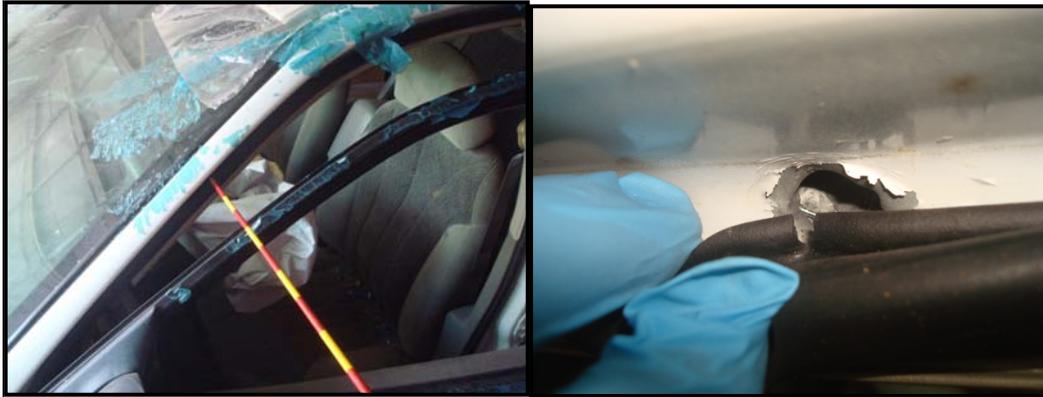
Photograph 9 and Photograph 10

The front driver's side A-Pillar showed evidence of bullet impact related damage. The bullet did not completely pass through the A-Pillar and became lodged within the A-Pillar structure. The trajectory vector for the bullet was approximately perpendicular to the vehicle's longitudinal axis, fired from outside the vehicle as the Chevrolet Malibu was pulling forward, after exiting the parking space. This shot was not fired from a shooter pinned between the interior driver's seat and the driver's door and was not fired at close range.

17. The bullet hole in the "A" pillar of the white Malibu, shown in Photograph 9 was not fired from a position between the driver's door and the interior driver's seat as testified by Mr. Garza. This bullet was fired by a tall standing person and from a distance. No powder burns were noted on the white Malibu. The shallow penetration of the bullet, which is still present. This evidence was critical to the investigation, yet was not noted or documented by police.

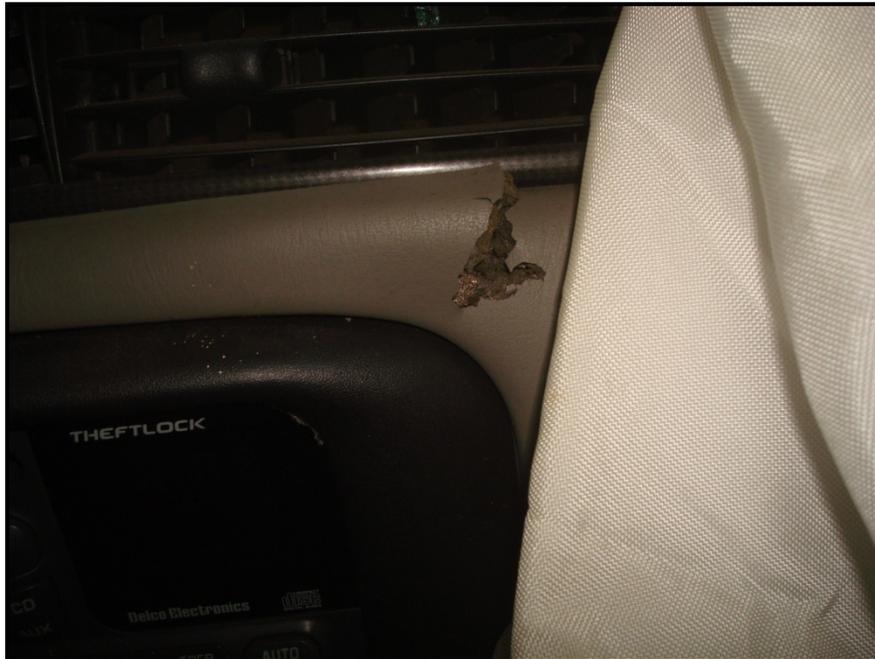
Photograph 11

Bullet impact related damage is present to the front dash to the upper right of the center-mounted radio. The impact damage is not consistent with a bullet that was fired from the side of the vehicle. The damage is more consistent with a bullet trajectory vector coming from the rear of the vehicle, most likely through the rear window. Had the bullet entered from an area just outside of the driver's side door, you would expect to see grazing or an elongated entry hole with even margins.

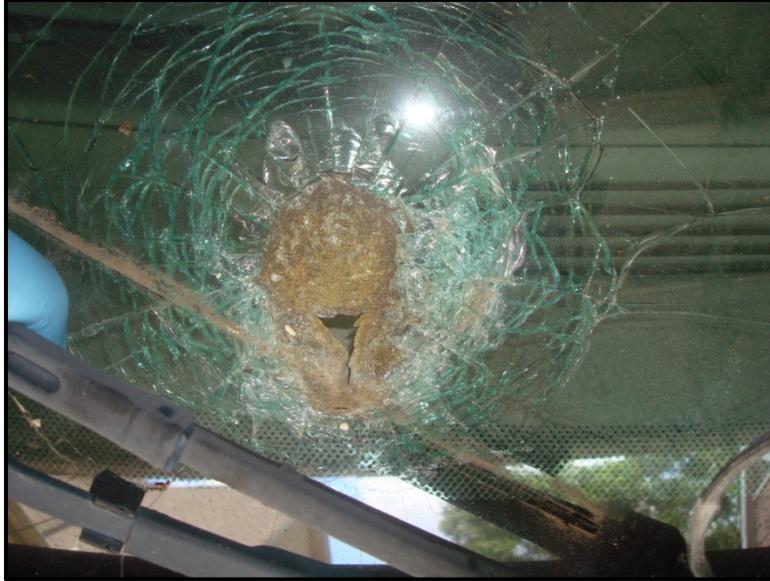
Photograph 12

An exit hole created from a bullet was present on the passenger's side of the front windshield. The bullet's trajectory vector is undetermined though the damage patterns present on the windshield would indicate a trajectory vector coming from the rear of the vehicle. The rear window made of tempered glass was shattered because of bullets impacting it as the Chevrolet Malibu drove away.
